## AFFORDABLE HOUSING COMMISSION

**Affordable Housing Commission Agenda Report**

**Agenda Subject:** Catherine property revised design (public comment opportunity)  
**Submitted by:**  
**Department:** Community Development

**RE: Wetland Monitoring Session #3 (FINAL) for Kittitas County parcel #69034 (Catherine Park, City of Ellensburg). NO WETLANDS PRESENT.**

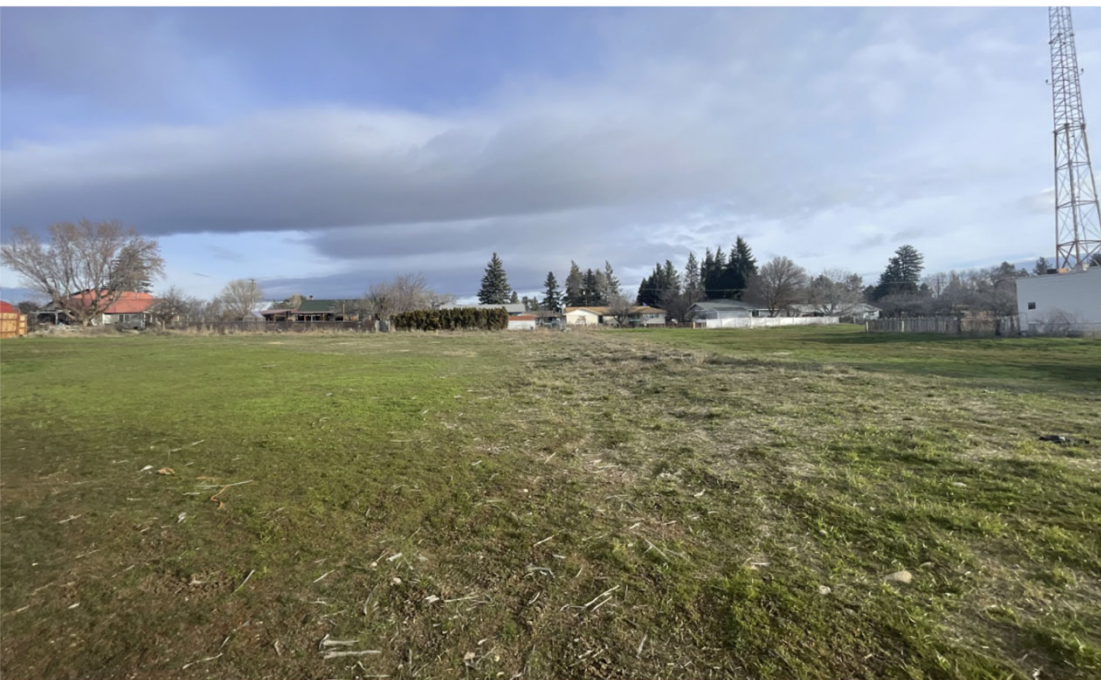
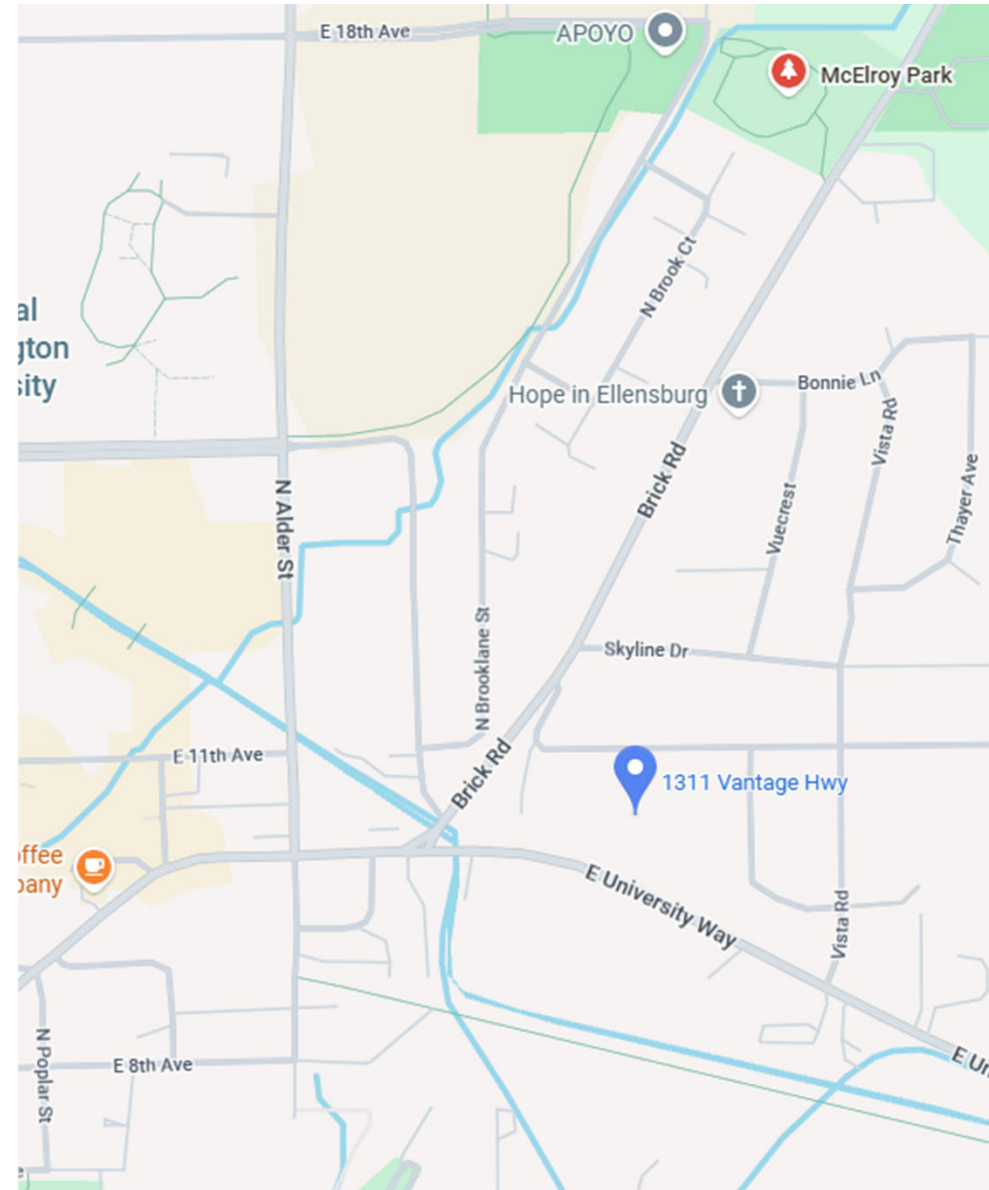
# Site Proposal – Catherine Cottages

- 9 New Permanently Affordable Homes
- 2 & 3 Bedroom Homes
- 18 Resident Parking Spaces
- Community walking path connecting to planned pedestrian improvements

The revised site plan shared by Habitat responds to parking and fire turnaround concerns raised in the Council discussion in 2023. City staff have done an initial review with Habitat to discuss relevant housing design provisions, fire access and to consider how the site plan will align with ongoing Vantage Highway improvement planning. The Vantage Highway project would offer improved pedestrian safety for future residents and access to transit stops.

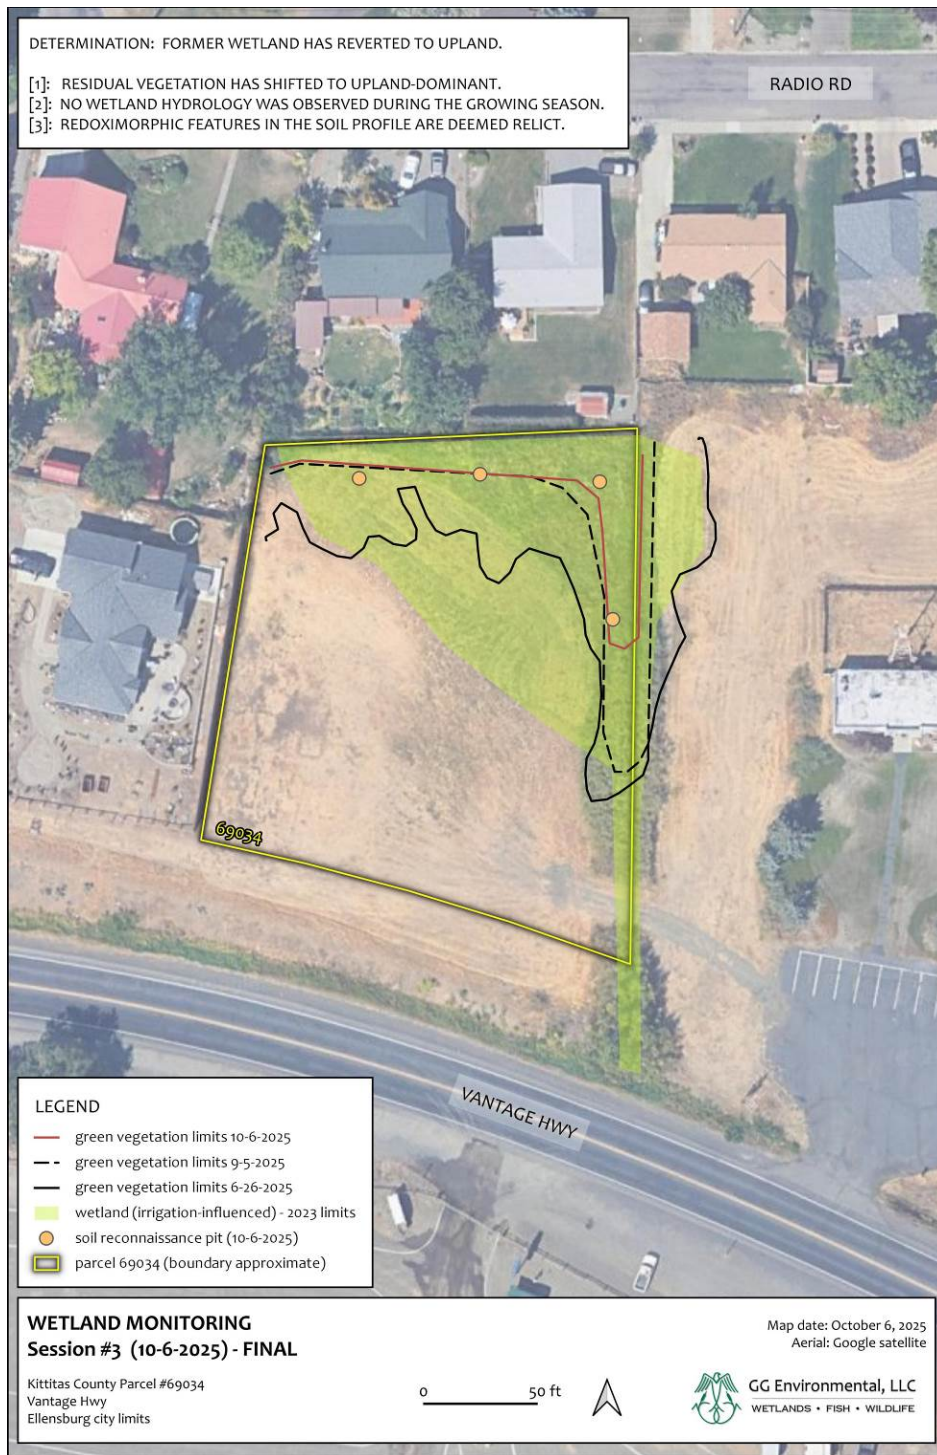
**Figure 2. Monitoring Map – Session #3 (10-6-2025) - FINAL**

Four soil reconnaissance pits were dug with a hand-held pick where green plants exhibit the most coverage (**Figure 2**). The soil profile was observed to be extremely hard, rocky, dry to 14 inches in depth, and exhibit redoximorphic concentrations, now relict in the absence of wetland hydrology. Water was no longer flowing from the culvert mouth at Vantage Highway.

Wetland hydrology was absent the entire growing season, as observed during the three monitoring visits. Vegetative coverage markedly reduced over time and has shifted to upland-dominant species. Redoximorphic features are still observable in the soil profile, but given the consistent lack of wetland hydrology, can be confidently characterized as relict.

According to best available science, it is determined that the former wetland was entirely supported by leaking irrigation infrastructure. Once the leak was repaired, the artificially-supported wetland reverted to upland.

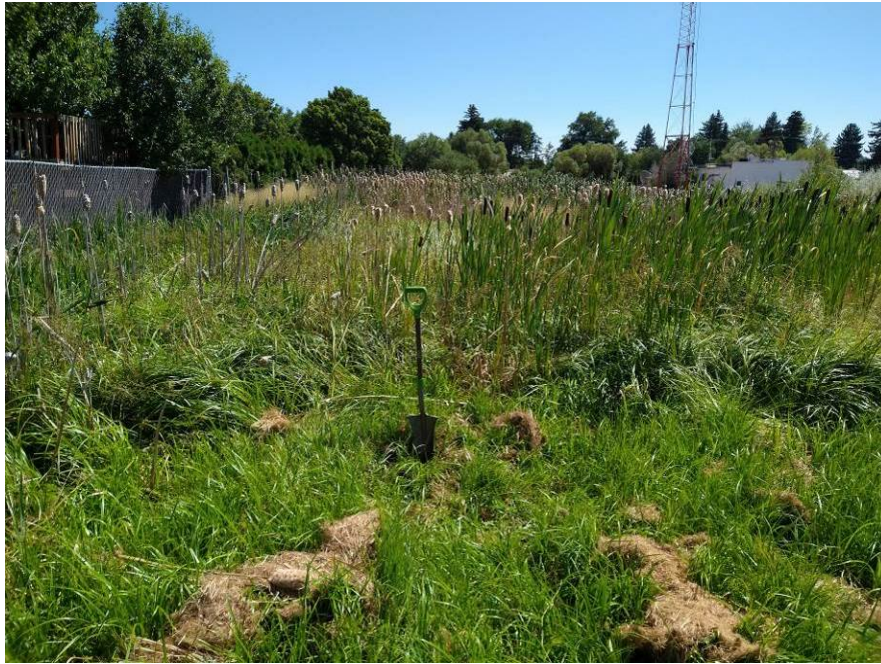
Vegetation was mowed for use as an automobile parking lot during the Ellensburg Rodeo in early September. Soils are very dry and compacted. Most vegetation is desiccated. The extent of residual green vegetation is further reduced from that observed in September (**Figure 2**). Surviving vegetation coverage is thinner and patchy, dominated by alfalfa (*Medicago sativa*), an upland (UPL) plant, likely from imported seed. Several wetland-associated plants still persist (sedge, iris, coyote willow), but these are few in number and exhibit water stress. Some perennial pasture grass species have resprouted in response to cooler weather and light rains. The progressive drying of the wetland, at the northern end of the parcel, is illustrated in **Photos 1-4**.

**Photo 1.** July 21, 2023. Northwest corner of the parcel, view toward east.

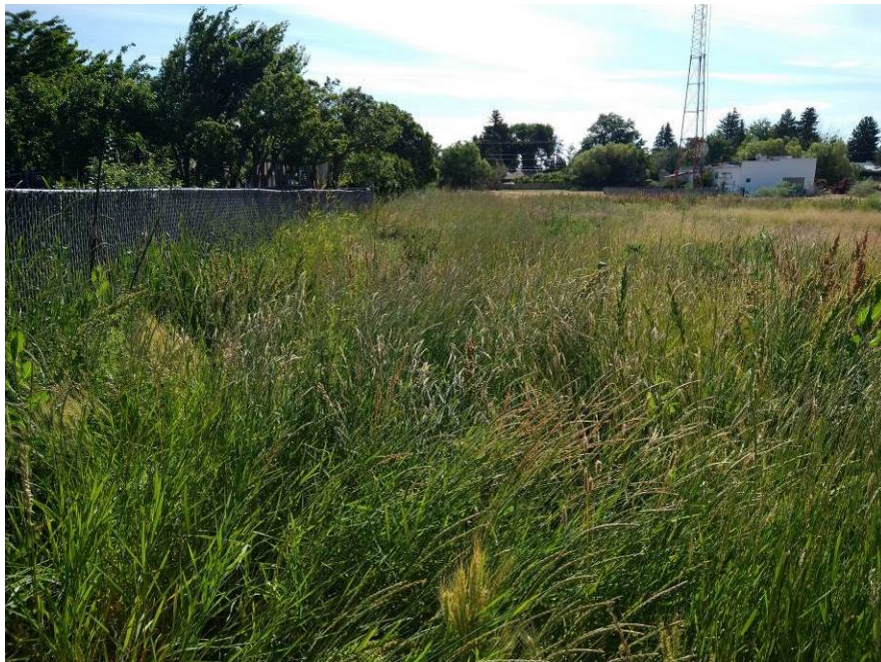
**Photo 2.** June 26, 2025. Northwest corner of the parcel, view toward east.

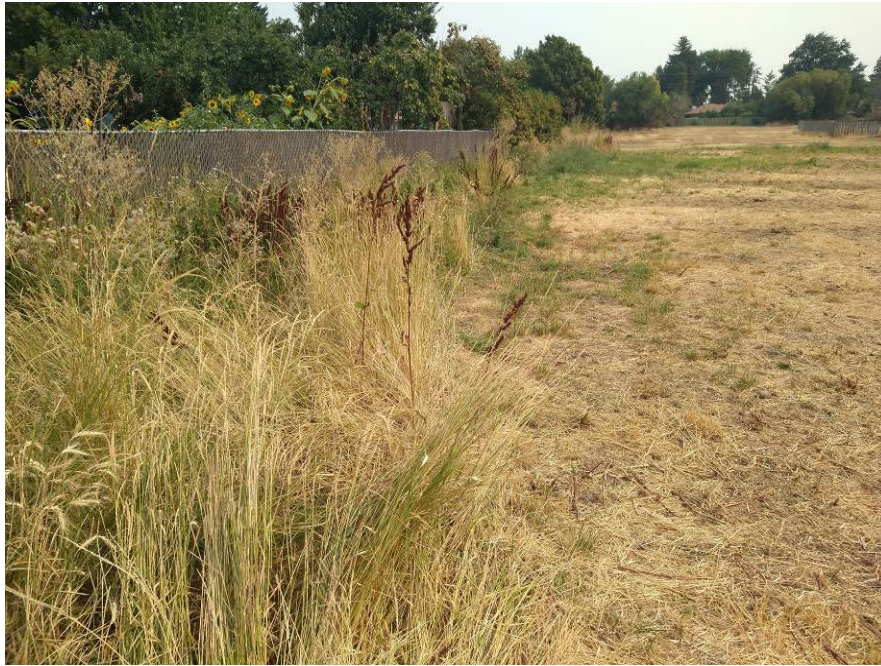
**Photo 3. September 5, 2025.** Northwest corner of the parcel, view toward east.

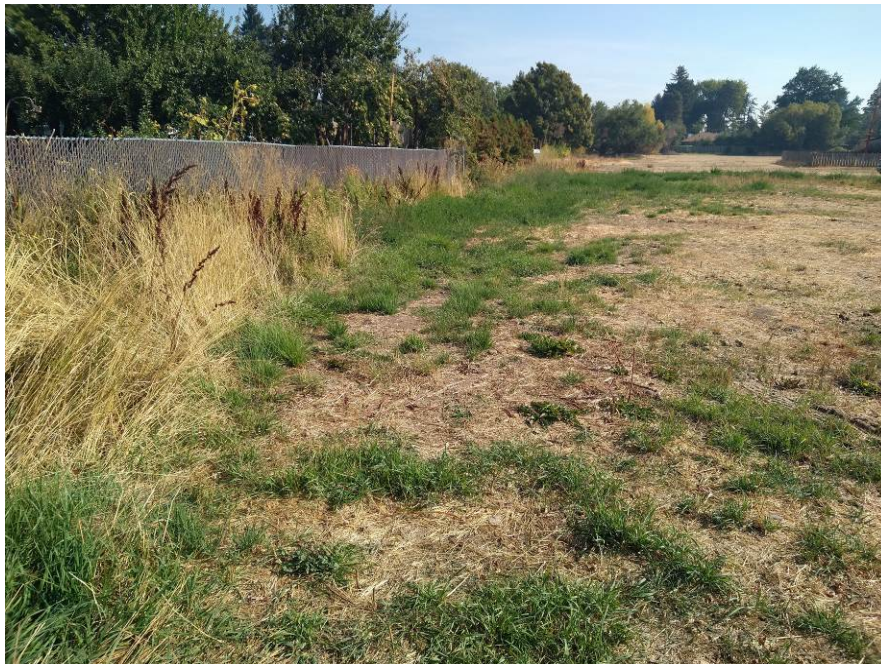
**Photo 4. October 6, 2025.** Northwest corner of the parcel, view toward east.

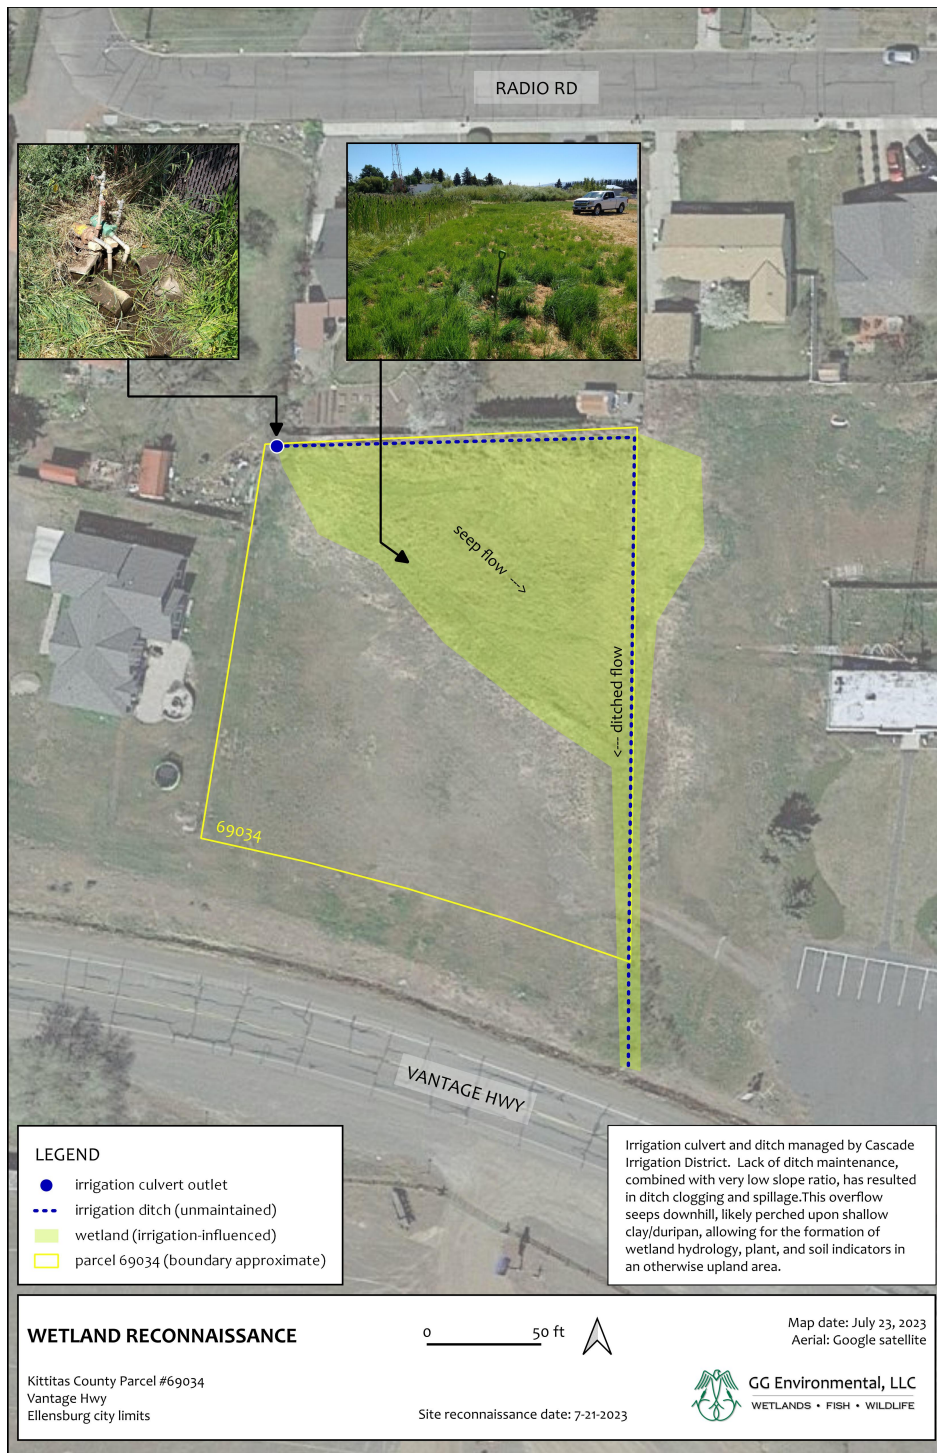
# Attachment 1. Reconnaissance Map

The parcel exhibits a patch of lush, wetland-obligate plants in the northeast quarter, dominated by cattails (*Typha latifolia*), red-stem bulrush (*Scirpus microcarpus*), and coyote willow (*Salix exigua*).

A Cascade Irrigation District<sup>11</sup> tailwater culvert outlet is present in the northwest corner of the parcel (**Attachment 1**). An irrigation ditch, clogged with dense vegetation, was observed at this location and, consistent with observed flow patterns and historic satellite imagery, the ditch continues along the parcel's northern and eastern limits. The slope ratio across the northern parcel boundary is very low, resulting in slow flow even under ideal conditions. Lack of ditch maintenance has allowed wetland plants to colonize the ditch profile, which in turn has resulted in root mass impoundment and sediment aggradation. No longer constrained within the ditch, water overflows and seeps down-gradient. Unable to rapidly infiltrate through shallow clay and duripan (as described by the NRCS), extended saturation supports wetland vegetation and hydric soil indicators (redoximorphic concentrations observed in the upper 12 inches of the soil profile).

In order to determine the jurisdictional status of the wetland, it is recommended that, at a minimum, the irrigation ditch be restored to its original configuration and function, thereby reducing the opportunity for water to leak. However, this action may not be sufficient to eliminate all wetland indicators downgradient of the ditch due to the potential for continued seepage. As such, the ideal manner by which to stop leakage and determine the wetland's jurisdictional status would be to line the existing ditch or pipe water across the parcel.

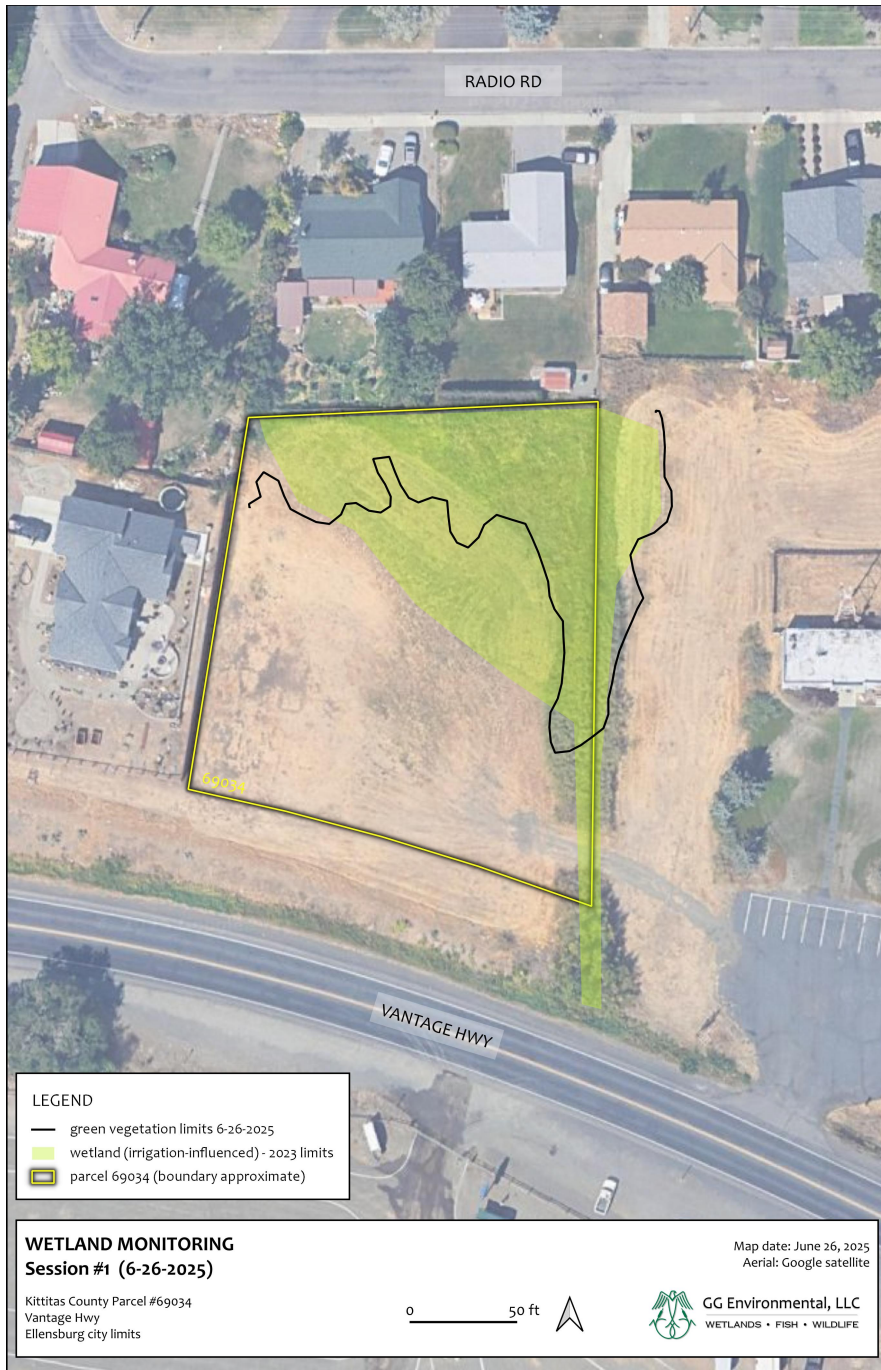
# Attachment 1. Monitoring Map – Session #1 (6-26-2025)

After a new culvert pipe was installed, soils were leveled and the former ditch alignment is no longer visible. Vigorous water flow was observed exiting the culvert mouth at Vantage Highway.

A xeric, hillside parcel, vegetation remains green in the same general vicinity of the 2023 wetland, but aerial coverage has been reduced in extent. Wetland plant species are still present, but exhibit signs of stress and stunting as they struggle to obtain moisture from the drier soil profile. An exception is along the northern parcel fence line where adjacent landowners irrigate back yards. This moisture is keeping the soil moist along the fence line, so wetland plants remain more vigorous. However, this artificial form of hydrology, although it may allow wetland plants to persist, is unlikely to support wetland soil and hydrology indicators.

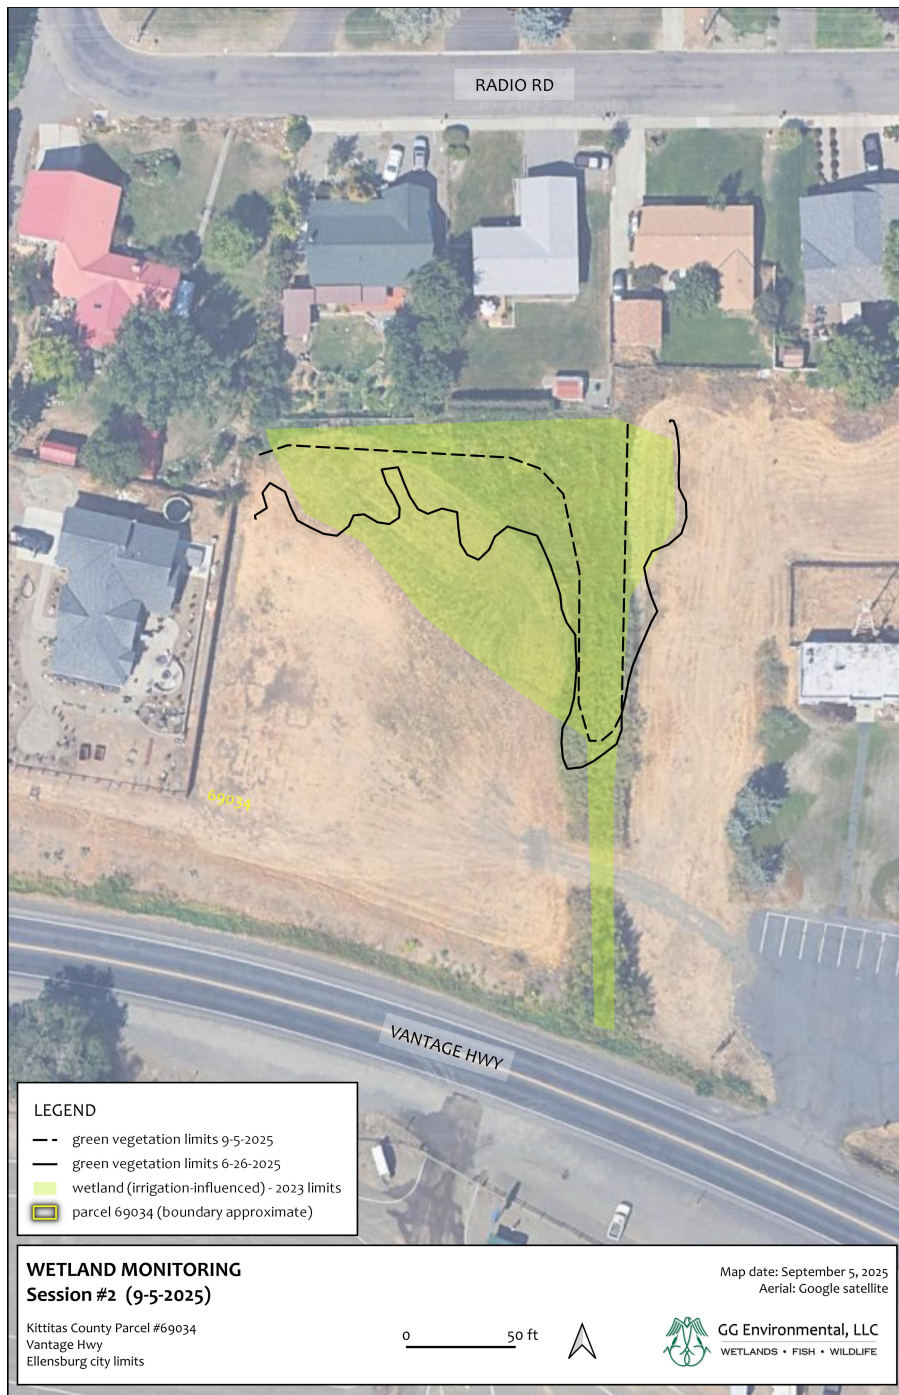
## Attachment 1. Monitoring Map – Session #2 (9-5-2025)

Vegetation is mowed and the parcel was recently utilized for automobile parking during the Ellensburg Rodeo. Soils are very dry and compacted. The extent of green vegetation within the former wetland polygon has further reduced since June. A single soil pit was dug where wetland plants are still alive. The soil profile was observed to be very dry to 14 inches in depth and included redoximorphic concentrations, now relict. Water was observed to be trickling from the culvert mouth at Vantage Highway.

Although some plants are still alive along the former ditch alignment, they exhibit signs of water stress. Non-native upland weeds are increasing in relative coverage while wetland plant cover is decreasing. The northern parcel fence line continues to receive incidental moisture from backyard irrigation. It is expected that this area will continue to support weeds but not receive sufficient hydrology to support wetland soil and hydrology indicators.
