## LANDMARKS & DESIGN COMMISSION

### August 15, 2023

**Ellensburg  
First Railroad Addition Historic District  
Survey Report**

*Prepared for*  
City of Ellensburg  
Community Development Department  
Ellensburg Landmarks and Design Commission  
DAHP# 2022-01-00206

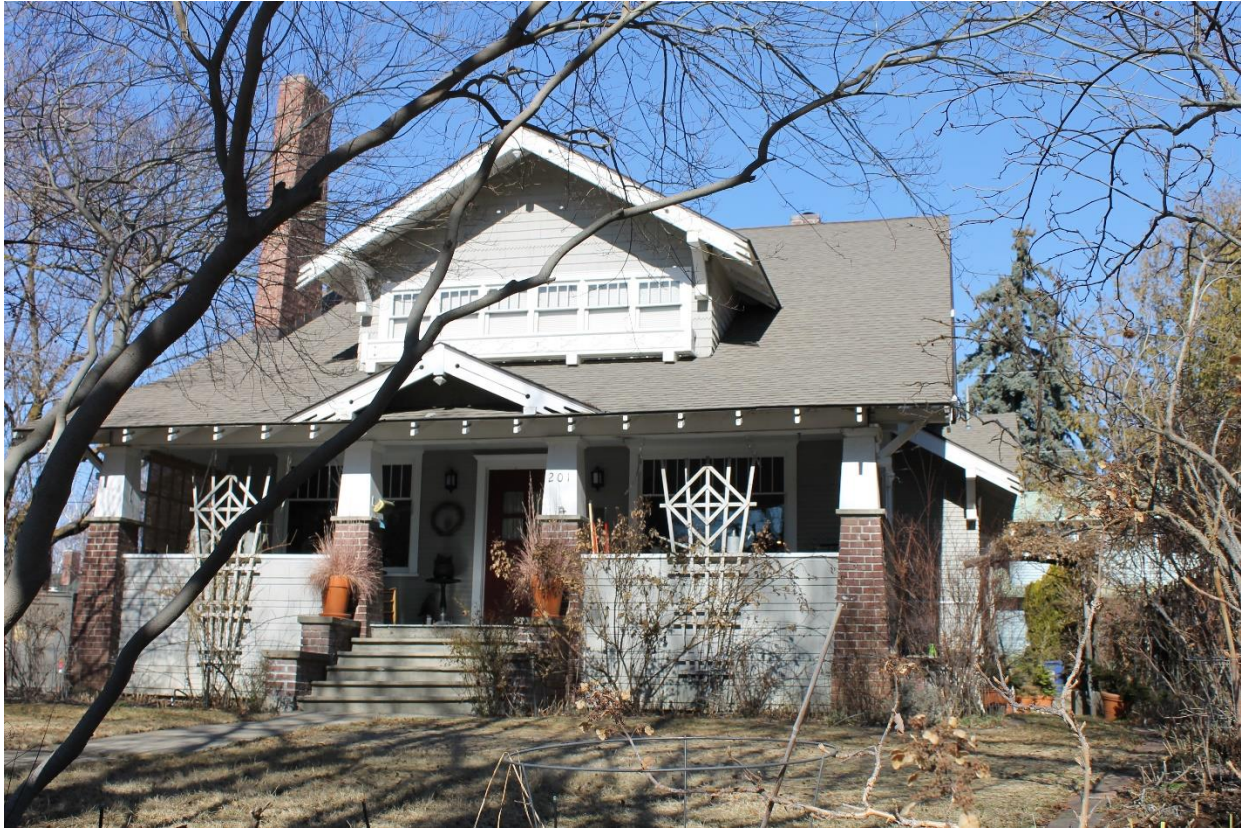
***Kelleher, John and Selina, House, 201 E. 9<sup>th</sup> Ave. (c. 1922). Photo by author.***

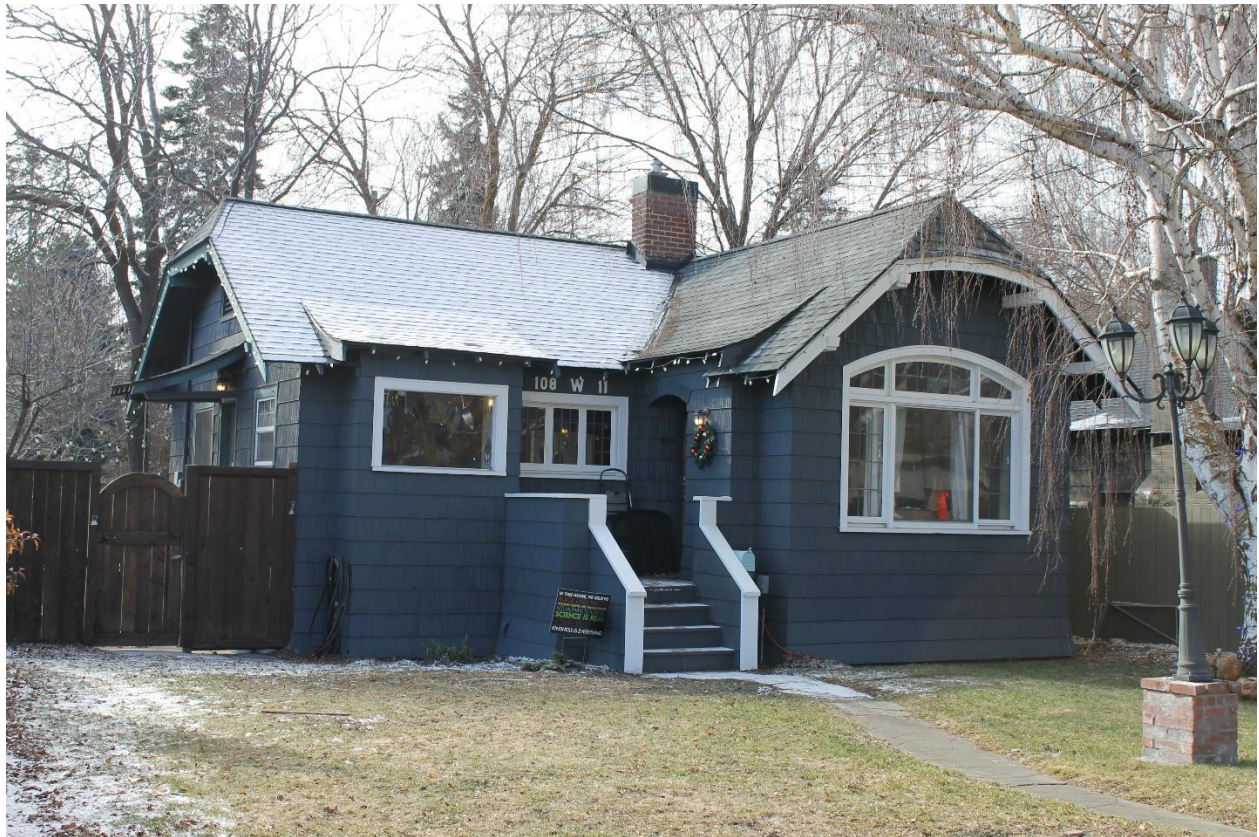
***House, 108 W. 11<sup>th</sup> Ave. (c. 1930). Photo by author.***

The northwest corner of the district and the south side of 11<sup>th</sup> Ave. were the last to be developed as the district slowly grew northward. Most of the homes on 11<sup>th</sup> Ave. were built between 1930 and 1940. In particular, a large concentration of mid-1930s homes is located on the western end of 11<sup>th</sup> Ave. All five of these were designed in a version of the Tudor Cottage style and encompass the entire block with the exception of the house at the far west end which was built circa 1900. The middle block of 11<sup>th</sup> Ave. has three homes with very little ornament and one more that was not constructed until 1952. The east end of 11<sup>th</sup> Ave. has a mixture of two circa 1900 homes, a 1930s Tudor Cottage and two later Minimal Traditional houses. Only two homes along 11<sup>th</sup> Ave., 112 W. 11<sup>th</sup> Ave. and 1006 N. C St, were shown on the 1909 Sanborn map and one more, on the 1928.<sup>18</sup>

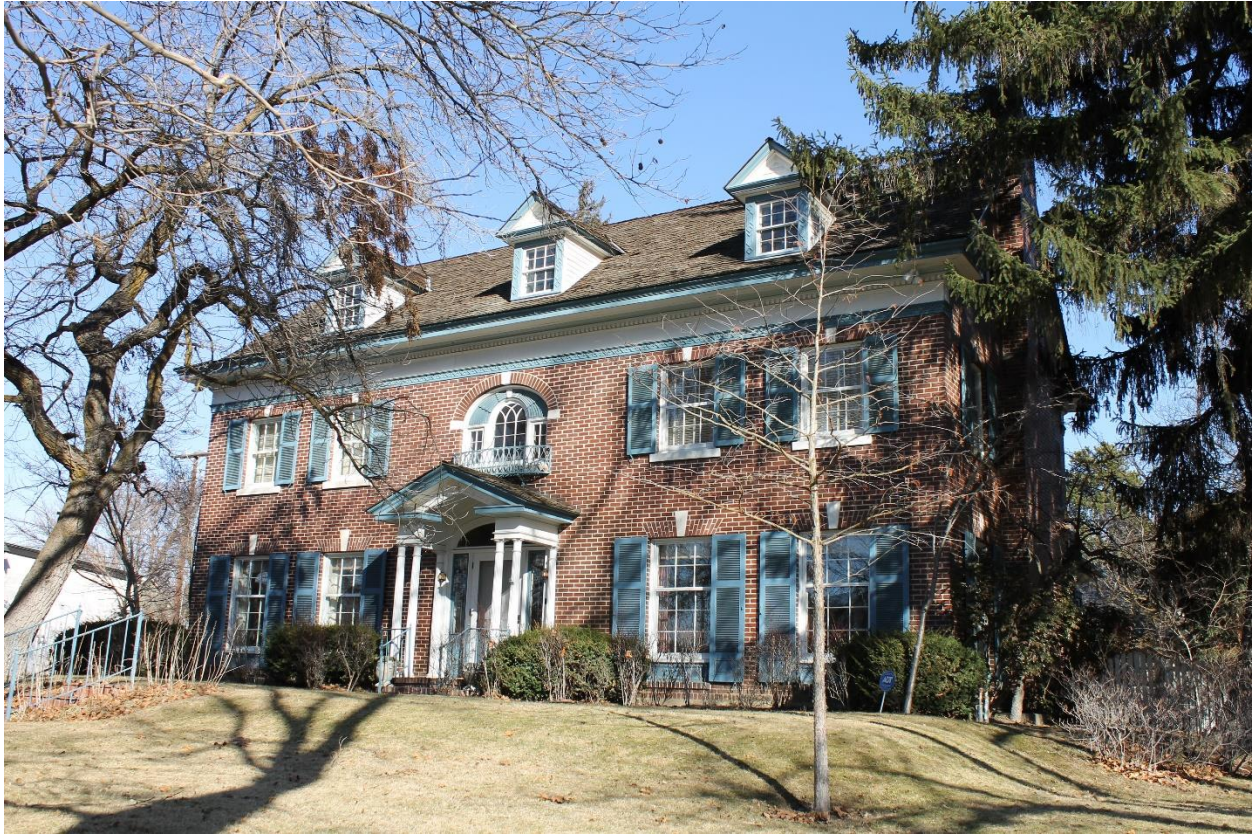
***Taylor, Dr. William, House, 1000 N. C St. (1930). Photo by author.***

By the 1930s, house styles started to shift toward period revival styles which is evidenced by the construction of houses such as Georgian Revival Dr. William Taylor Residence at 1000 North C Street which was built circa 1930, the French Norman style residence at 1004 North B Street, circa 1934, and the cluster of Tudor Cottages on the west end of 11<sup>th</sup> Ave. circa 1930s.

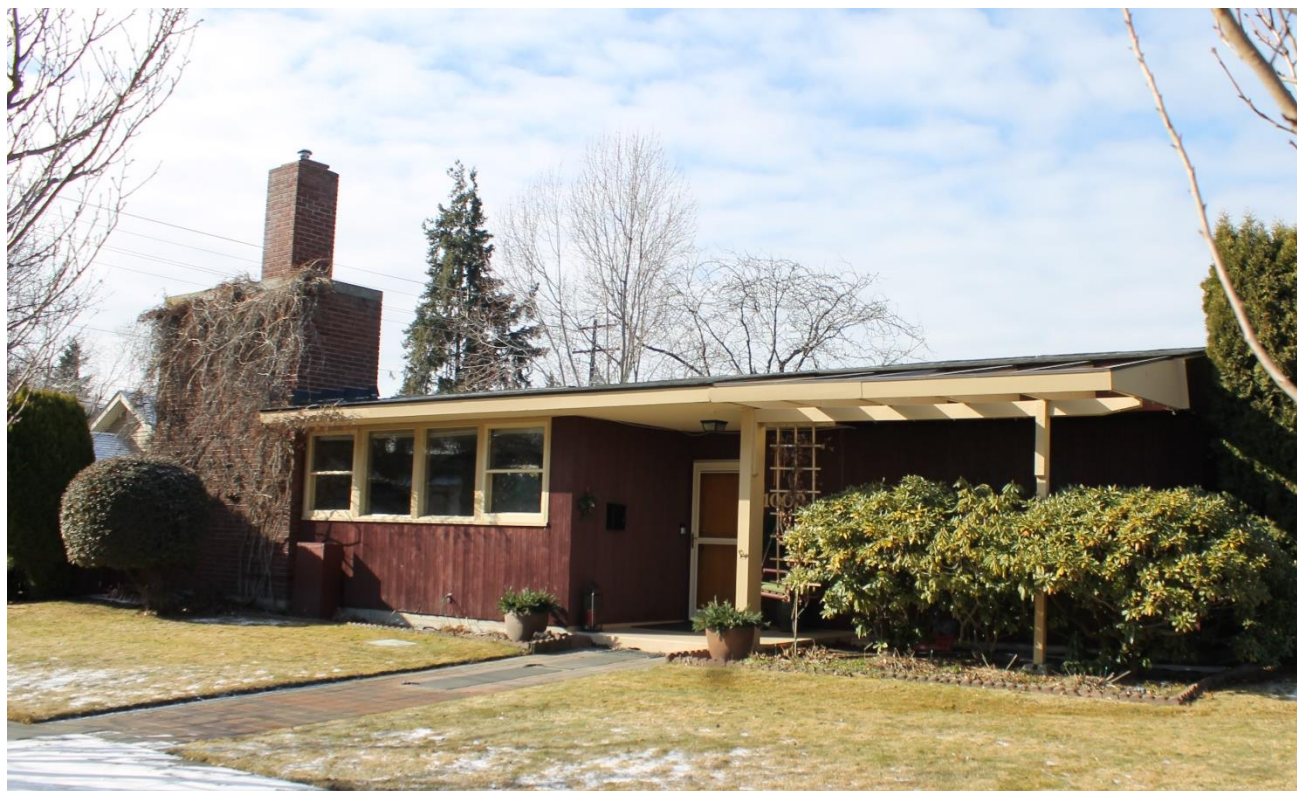
*Whitney, Henry J., House, 1009 N. C St. (1952). Photo by author.*

In 1952, a Modern house designed by John W. Maloney, was built at the southwest corner of N. C St. and E. 11<sup>th</sup> Ave., completing the infill on that street. Between 1952 and 1972, one home and one apartment building were built in the district, circa 1967-68, each replacing an older structure. In 1967, the CWU President's House was drastically altered and expanded and the houses to its east were razed. Finally, in the early 1980s, a Shed style home was built at 104 W 10<sup>th</sup> Ave. Since that time, two new homes have been built in place of homes that were destroyed or demolished.

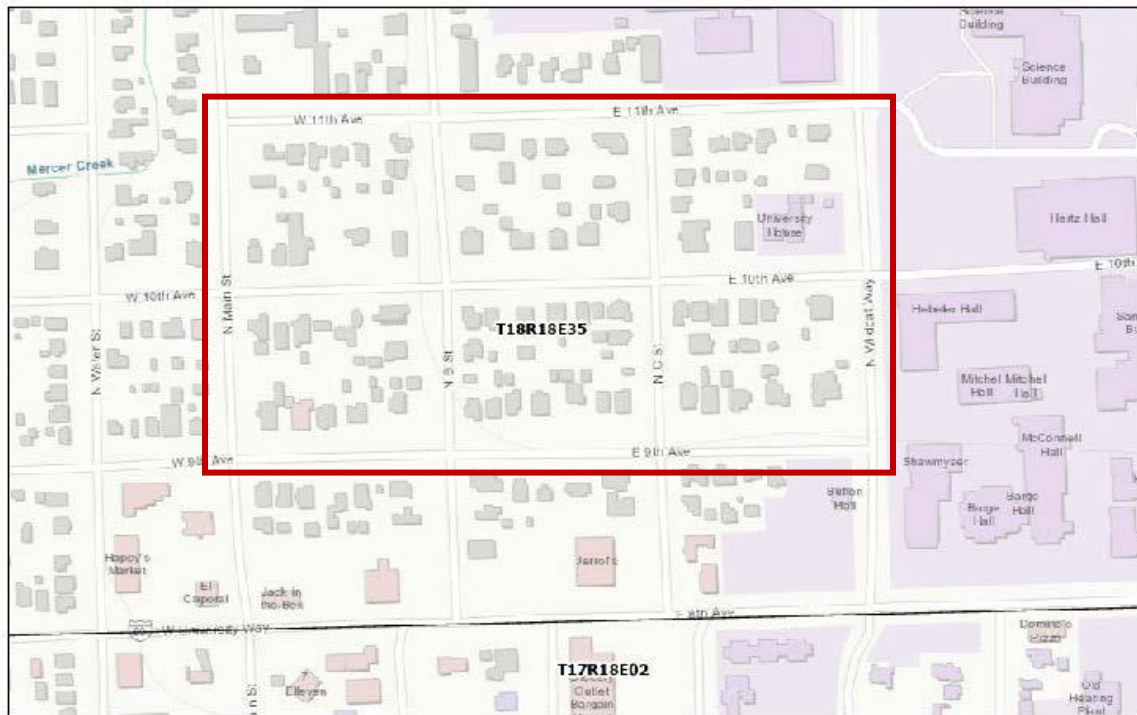
Based on the data from the survey, the original National Register boundaries continue to retain sufficient integrity, and an amended National Register boundary could encompass the local register historic district as shown below. The revised boundary should include properties from the south side of 11<sup>th</sup> Ave to the north side of 9<sup>th</sup> Ave. between N. Main St. and N. Wildcat Way.

Given the placement of new contributing properties along 11<sup>th</sup> Ave. and the east and west ends of 10<sup>th</sup> Ave., the local district boundaries would be appropriate for a revised National Register historic district.

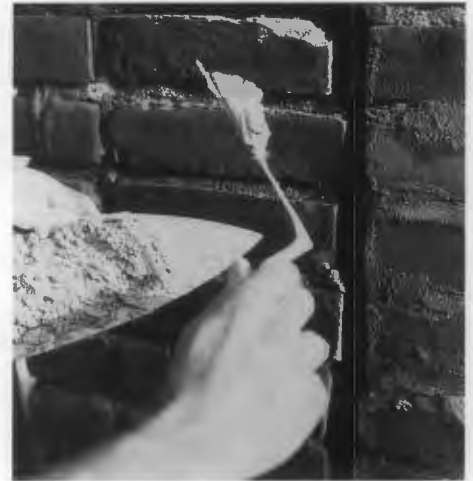
Figure 1. After removing deteriorated mortar, an experienced mason repoints a portion of this early-20th century limestone building. Photo: Robert C. Mack, FAIA.

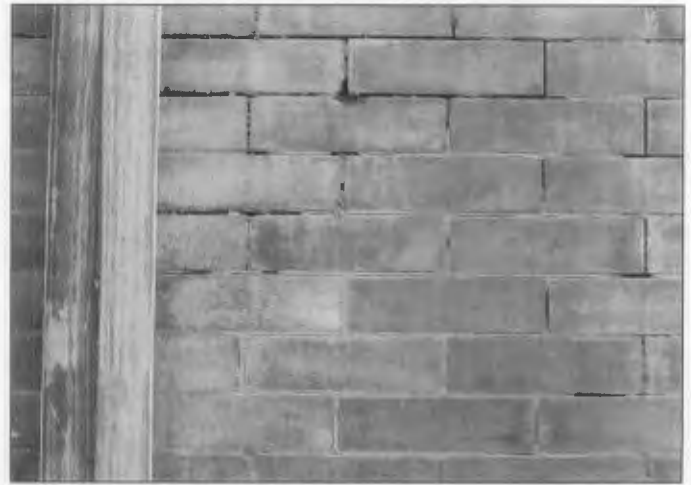
Figure 2. Much of the mortar on this building has been leached away by water from a leaking downspout. The downspout must be replaced and any other drainage problems repaired before repointing. Photo: Robert C. Mack, FAIA.

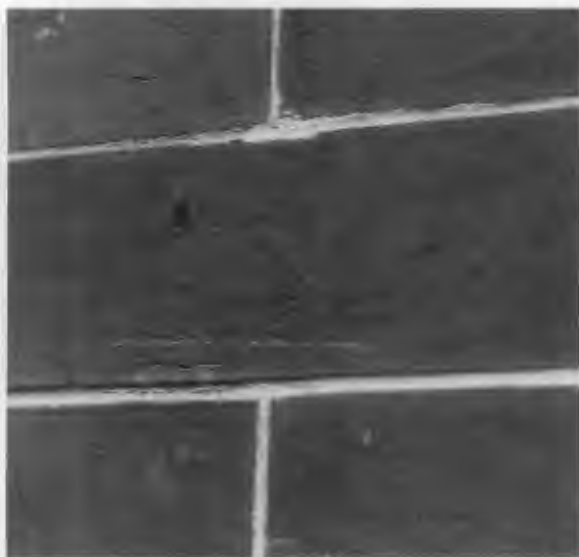
Figure 3. Good-quality repointing closely replicates the original in composition, texture, joint type and profile on this 19th century brick building (left), and on this late-19th century granite on H.H. Richardson's Glessner House in Chicago (right). Photos: Charles E. Fisher; Sharon C. Park, FAIA.

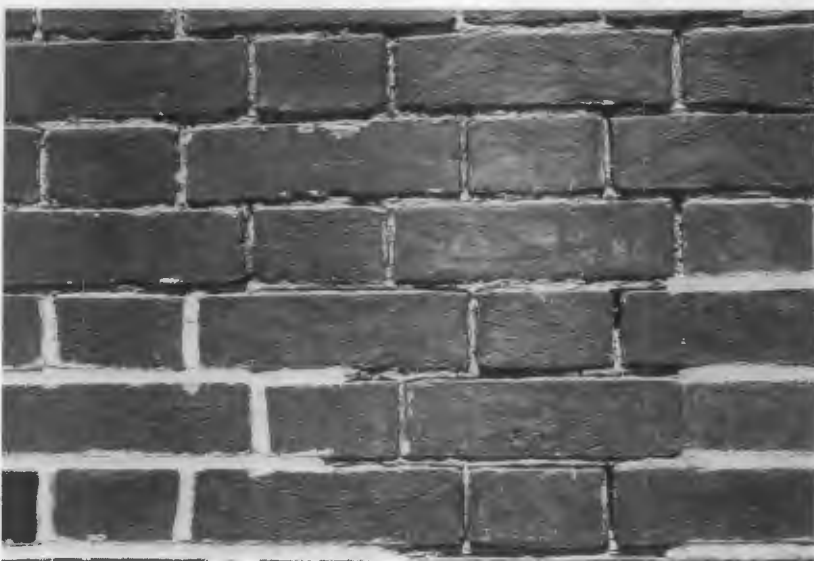
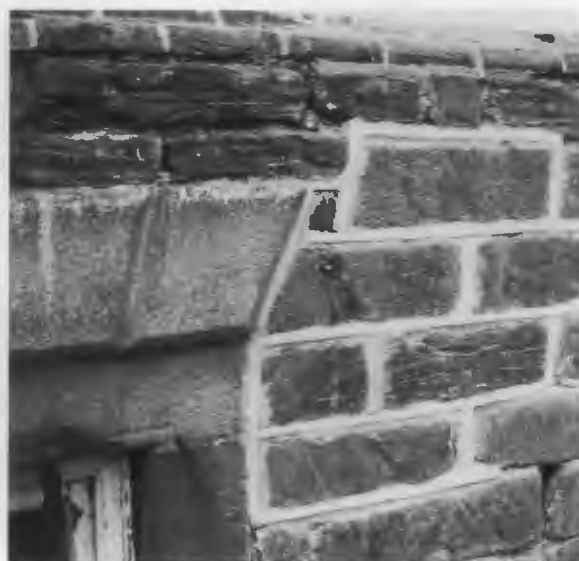
Figure 4. (left) The poor quality of this repointing—it appears to have been “tooled” with the mason’s finger—does not match the delicacy of the original beaded joint on this 19th-century brick wall. (right) It is obvious that the repointing on this “test patch” is not an appropriate replacement mortar joint for this early-19th century stone foundation. Photos: Lee H. Nelson, FAIA.

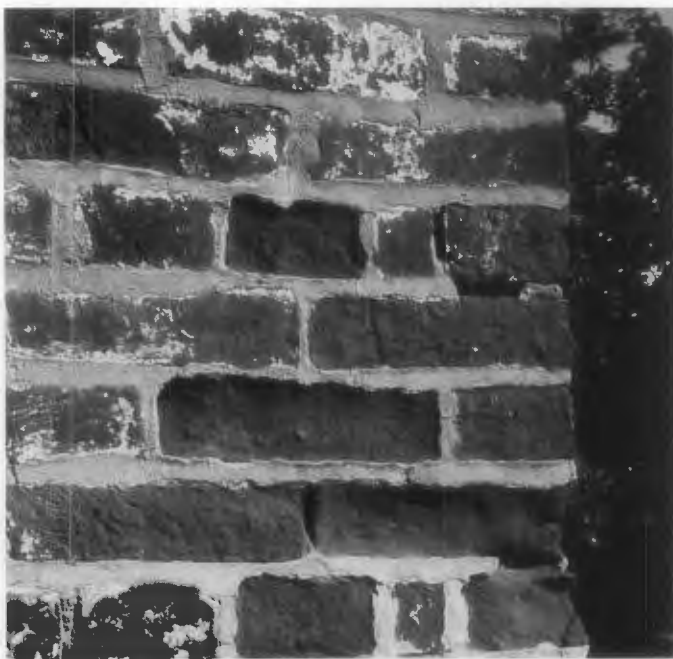
Figure 5. The use of hard, portland-cement mortar that is less permeable than the soft bricks has resulted in severe damage to this brick wall. Moisture trapped in the wall was unable to evaporate through the mortar which is intended to be sacrificial, and thus protect the bricks. As a result the moisture remained in the walls until water pressure eventually popped the surface off the bricks. Photo: National Park Service Files.

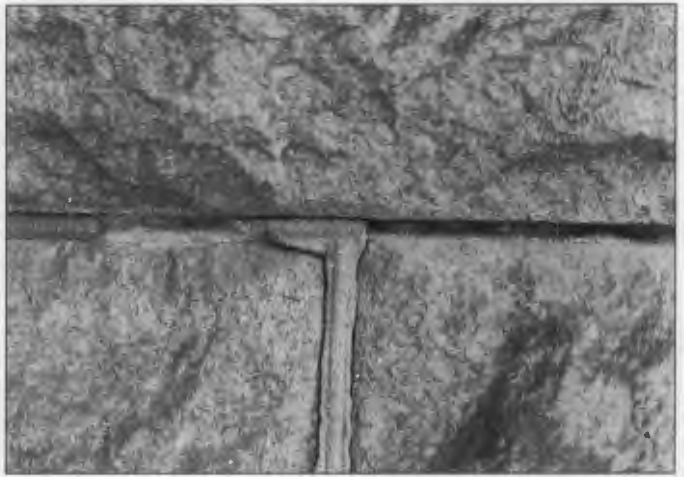
Figure 8. Due to inadequate joint preparation, the repointing mortar has not adhered properly and is falling out of the joint. Photo: Robert C. Mack, FAIA.

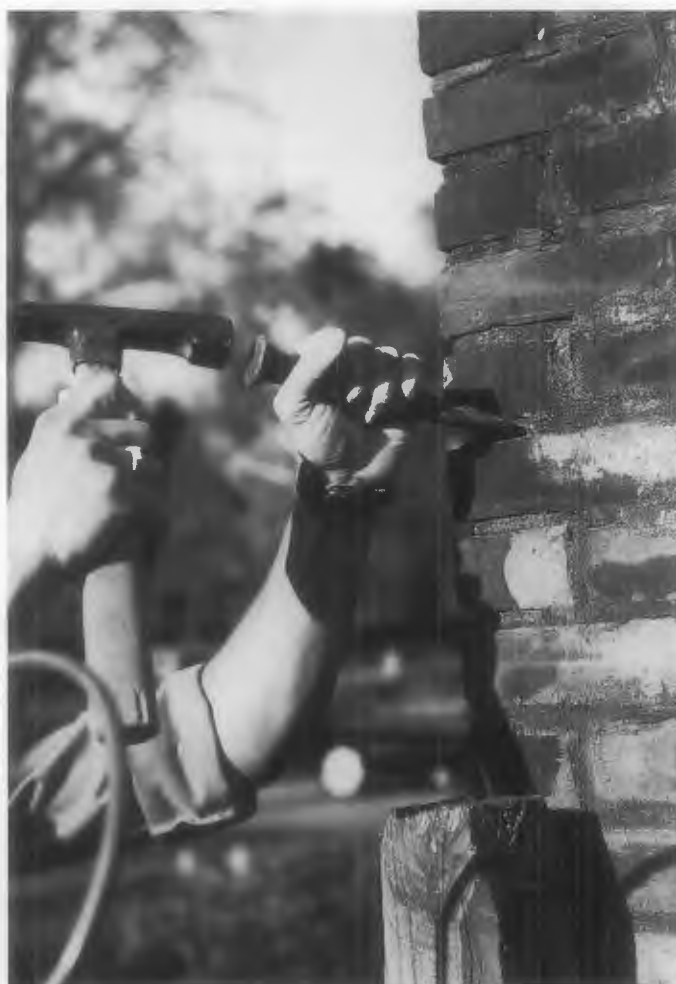
Figure 10. Using a hammer and masonry chisel is the least damaging and, thus, generally the preferred method of removing old mortar in preparation for repointing historic masonry. Photo: John P. Speweik.

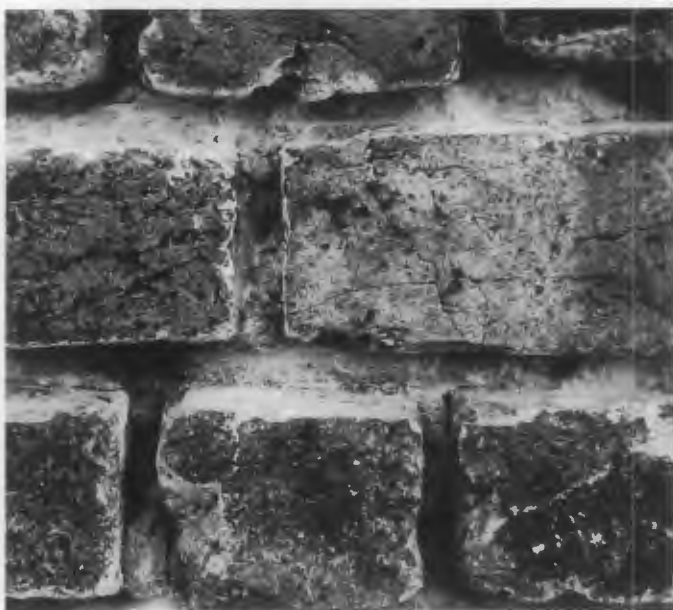
Figure 11. The damage to the edges and corners of these historic bricks was caused by using a mechanical grinder to rake out the joints. Note the overcutting of the head joint and the damage to the arises (corners) of the bricks. Photo: Lee H. Nelson, FAIA.

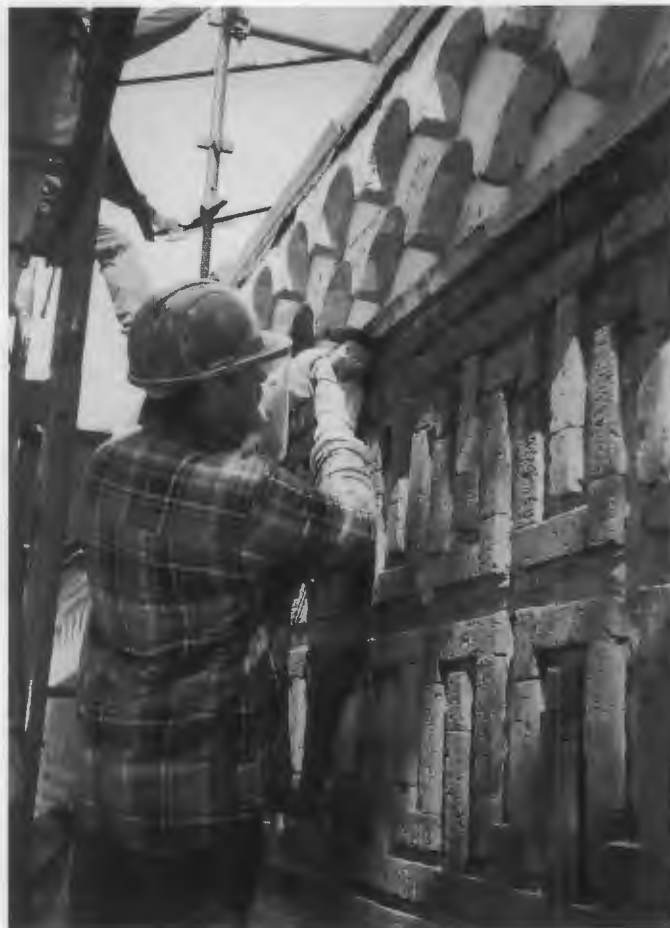
Figure 12.. A power grinder, operated correctly by a skilled mason may be used in preparation for repointing to cut wide, horizontal mortar joints, typical of many early-20th century brick structures without causing damage to the brick. Note the use of protective safety equipment. Photo: Robert C. Mack, FAIA.

Under certain circumstances, thin diamond-bladed grinders may be used to cut out *horizontal* joints only on hard portland cement mortar common to most early-20th century masonry buildings (Fig. 12). Usually, automatic tools most successfully remove old mortar without damaging the masonry units when they are used in combination with hand tools in preparation for repointing. Where horizontal joints are uniform and fairly wide, it may be possible to use a power masonry saw to assist the removal of mortar, such as by cutting along the middle of the joint; final mortar removal from the sides of the joints still should be done with a hand chisel and hammer. Caulking cutters with diamond blades can sometimes be used successfully to cut out joints without damaging the masonry. Caulking cutters are slow; they do not rotate, but vibrate at very high speeds, thus minimizing the possibility of damage to masonry units (Fig. 13). Although mechanical tools may be used safely in limited circumstances to cut out horizontal joints in preparation for repointing, they should never be used on vertical joints because of the danger of slipping and cutting into the brick above or below the vertical joint. Using power tools to remove mortar without damaging the surrounding masonry units also necessitates highly skilled masons experienced in working on historic masonry buildings. Contractors

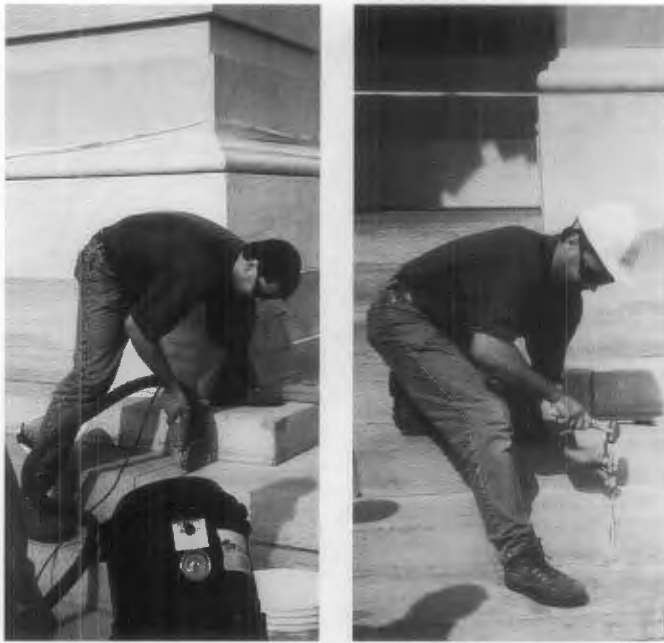
Figure 13. (left) In preparation for repointing, the mortar joints on these granite steps are first cut out mechanically (note the vacuum attached to the cutting tool in foreground to cut down on dust). (right) Final removal of the old mortar is done by hand to avoid damage to the edges of the joints. Mechanical preparation of horizontal joints by an experienced mason may sometimes be acceptable, especially where the joints are quite wide and the masonry is a very hard stone. Photos: Anne Grimmer.

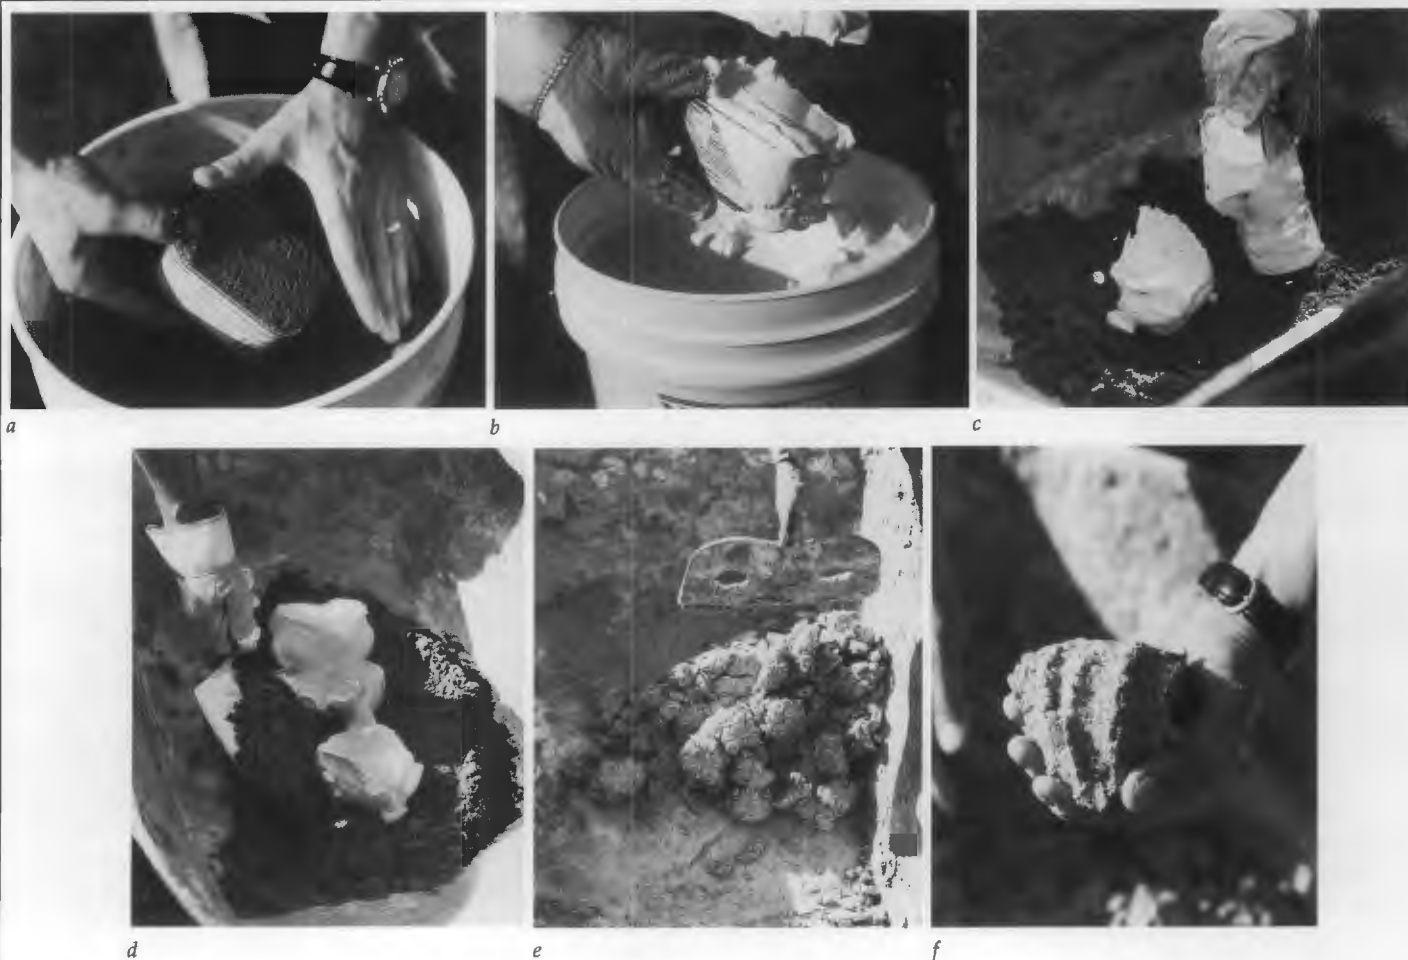
Figure 14. Mixing mortar using lime putty: (a) proportioning sand; (b) proportioning lime putty; (c) placing lime putty on top of sand; (d) mixing sand over lime putty; (e) hand mixing mortar; and, (f) sample of mortar after mixing. Photos: John P. Speweik.

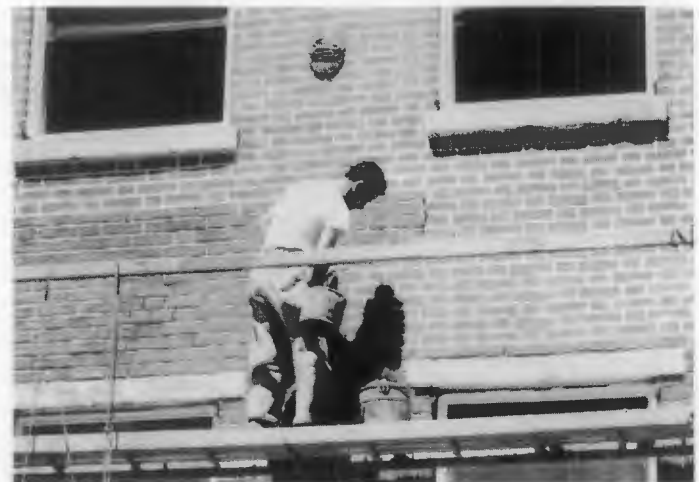
Figure 17. This photograph shows the significant visual change to the character of this historic brick building that has resulted from improper repointing procedures and a noticeably increased thickness of the mortar joints. Photo: Lee H. Nelson, FAIA.

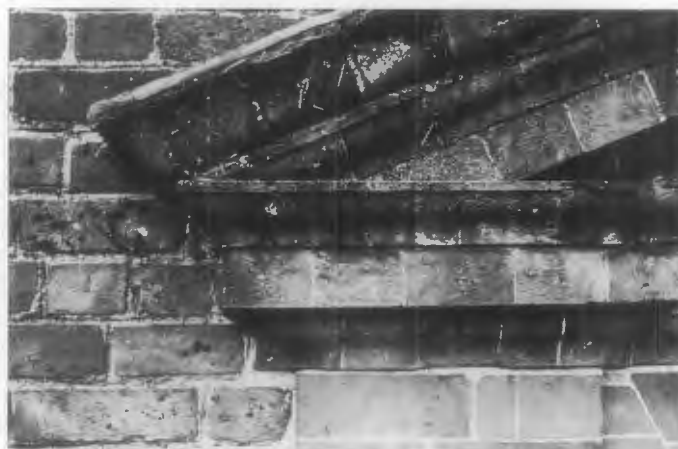
Figure 19. Mortar joints of 18th century brick buildings were often as much as 1/2 inch wide, cut flush and struck with a grapevine joint, but for window and door surrounds where a finer quality rubbed brick was used, mortar joints were very thin. Photo: National Park Service Files.

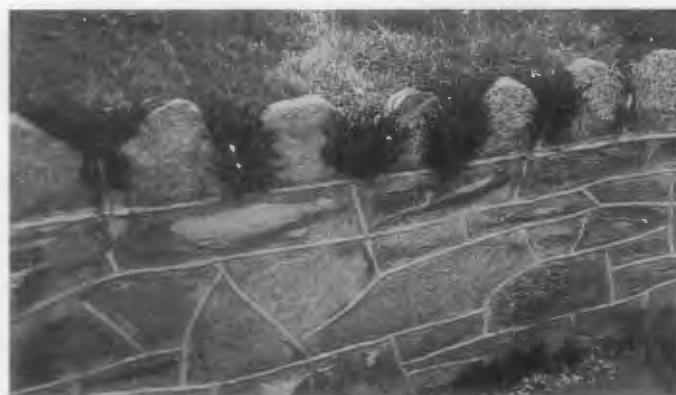
Figure 20. This stone garden wall was tuckpointed to match the tuckpointing on the c. 1920s house on the property. Photo: Anne Grimmer.

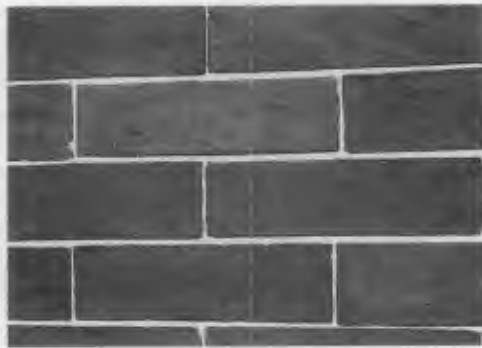
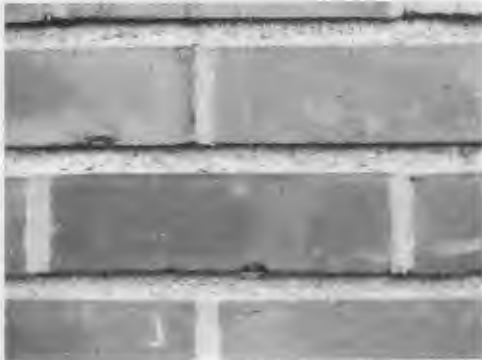
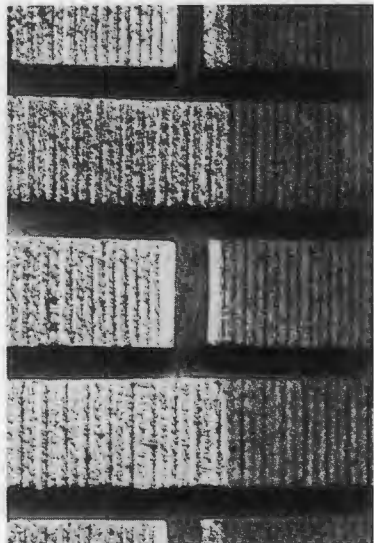
Figure 18. A cross-section of mortar joint types. (a) Grapevine joints on a mid-18th century brick building; (b) flush joints on a mid-to-late 19th century brick building; (c) beaded joints on a late-19th century brick building; (d) early-20th century beaded joints on rough-cut limestone where the vertical joints were struck prior to the horizontal joints; (e) raked joints on 1920s wire brick; (f) horizontal joints on a 1934 building designed by Frank Lloyd Wright where the vertical joints were raked back from the face of the bricks, and the horizontal joints were filled with a red-tinted mortar to emphasize the horizontality of the narrow bricks, and struck flush with the face of the bricks; (g) the joints on this 20th century glazed terracotta tile building are raked slightly, emphasizing the glazed block face. Photos: National Park Service Files (a,b,e); Robert C. Mack, FAIA (c,d,f,g).
